DEPARTMENT OF TRANSPORTATION**DIVISION OF ENGINEERING SERVICES**

Contract #: 04-0120F4Cty: SF/ALA Rte: 80 PM: 13.2/13.9File #: 69.28**WELDING INSPECTION REPORT****Resident Engineer:**Pursell, Gary**Address:** 333 Burma Road**City:** Oakland, CA 94607**Report No:** WIR-013097**Date Inspected:** 03-Apr-2010**Project Name:** SAS Superstructure**OSM Arrival Time:** 700**Prime Contractor:** American Bridge/Fluor Enterprises, a JV**OSM Departure Time:** 1900**Contractor:** Zhenhua Port Machinery Company, Ltd (ZPMC), Changxing Island **Location:** Shanghai, China**CWI Name:** Li Yang**CWI Present:** Yes No**Inspected CWI report:** Yes No N/A**Rod Oven in Use:** Yes No N/A**Electrode to specification:** Yes No N/A**Weld Procedures Followed:** Yes No N/A**Qualified Welders:** Yes No N/A**Verified Joint Fit-up:** Yes No N/A**Approved Drawings:** Yes No N/A**Approved WPS:** Yes No N/A**Delayed / Cancelled:** Yes No N/A**Bridge No:** 34-0006**Component:** Orthotropic Box Girder (OBG)**Summary of Items Observed:**

OBG # TRIAL ASSEMBLY YARD

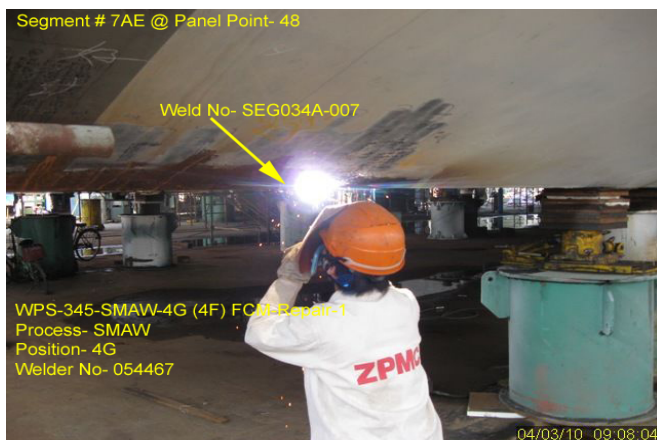
This QA inspector observed, ZPMC qualified welding personnel identified as 054467 perform Shielded Metal Arc Welding (SMAW), weld joint identified as SEG034A-007; The Critical Welding Repair Report (CWRR) was B-CWR1211. ZPMC QC is identified as Mr. Wang Li Yang. The welding parameters measured using QC's calibrated instrument appeared to be in general compliance with WPS-345-SMAW-4G (4F)-FCM-Repair-1. See the attached below Photo.
